Report on Water Seepage Investigation at Island View

MCST 1131

Integraal Building Consultancy and Services Pte Ltd

24 January 2025

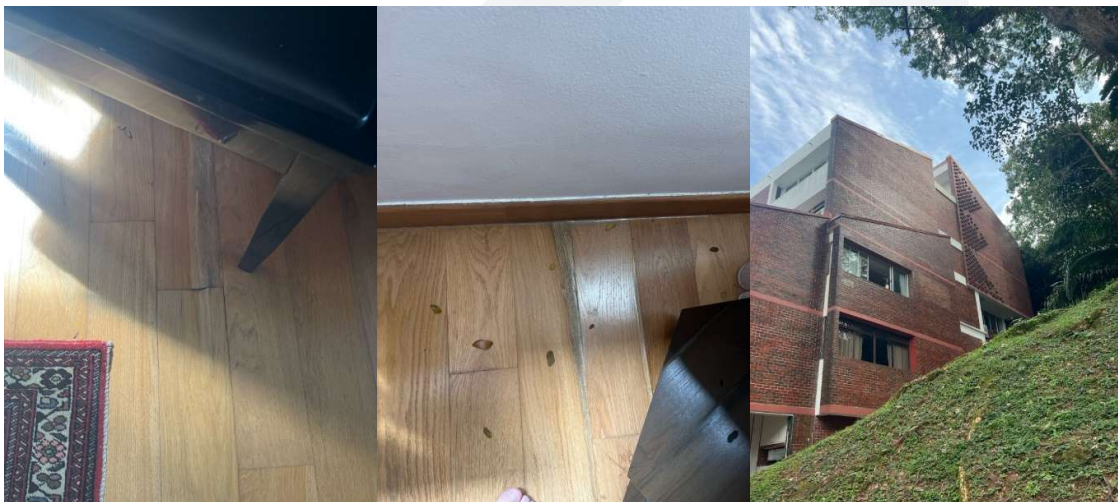
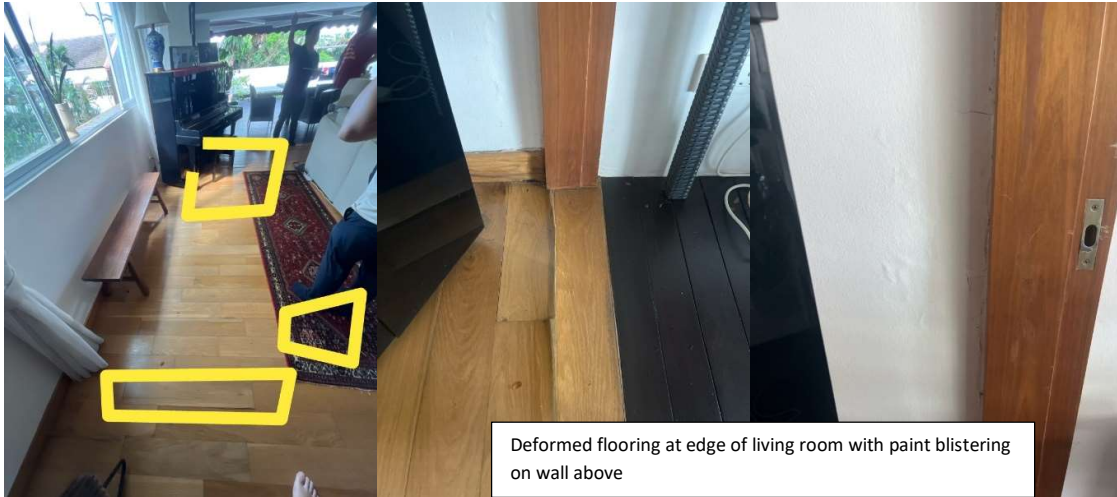
Plate 1 – Seepage photos in living room of Block B02-20

- 3.4.1. Within Block B unit 02-20, the parquet flooring immediately adjacent to the gable end walls were noted to be warped and debonded. Additionally, water marks could be observed along the edges of the parquet strips, and along the perimeter of the living room walls. See Plate 1.

The symptoms observed alludes to water retention issues beneath the parquet strips, and along the perimeter walls. Visually, the symptoms observed were noted to be worst adjacent to the gable end wall. The symptoms were noted to be less extensive and less severe further away from the gable end walls. It is therefore hypothesised that the seepage symptoms observed were attributed to seepages through the gable end walls.

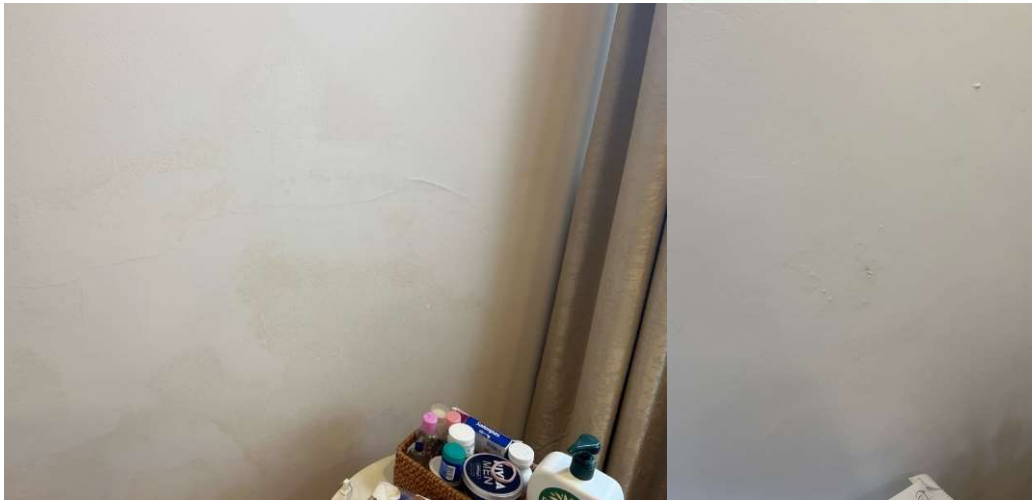
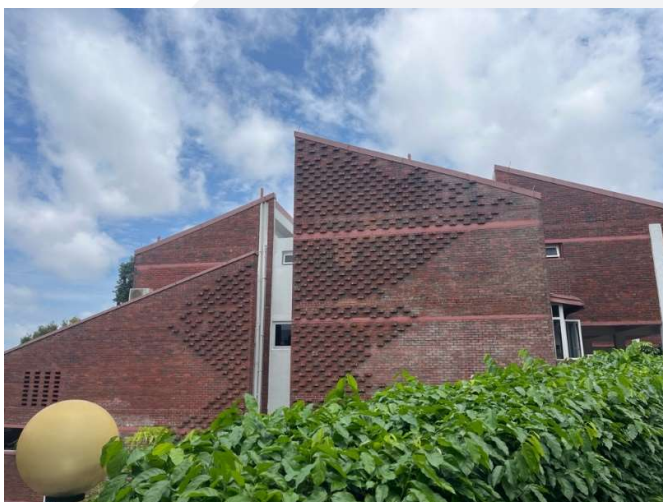
Plate 2 – Seepage photos in bedroom of Block C02-16

Similarly for Block C unit 02-16, the walls immediately adjacent to the gable end walls were noted with symptoms of water retention- these includes paint deterioration and water marks. See Plate 2

While repair works had previously been carried out to the exterior masonry walls, the repair works may not have fully arrested the seepage issue.

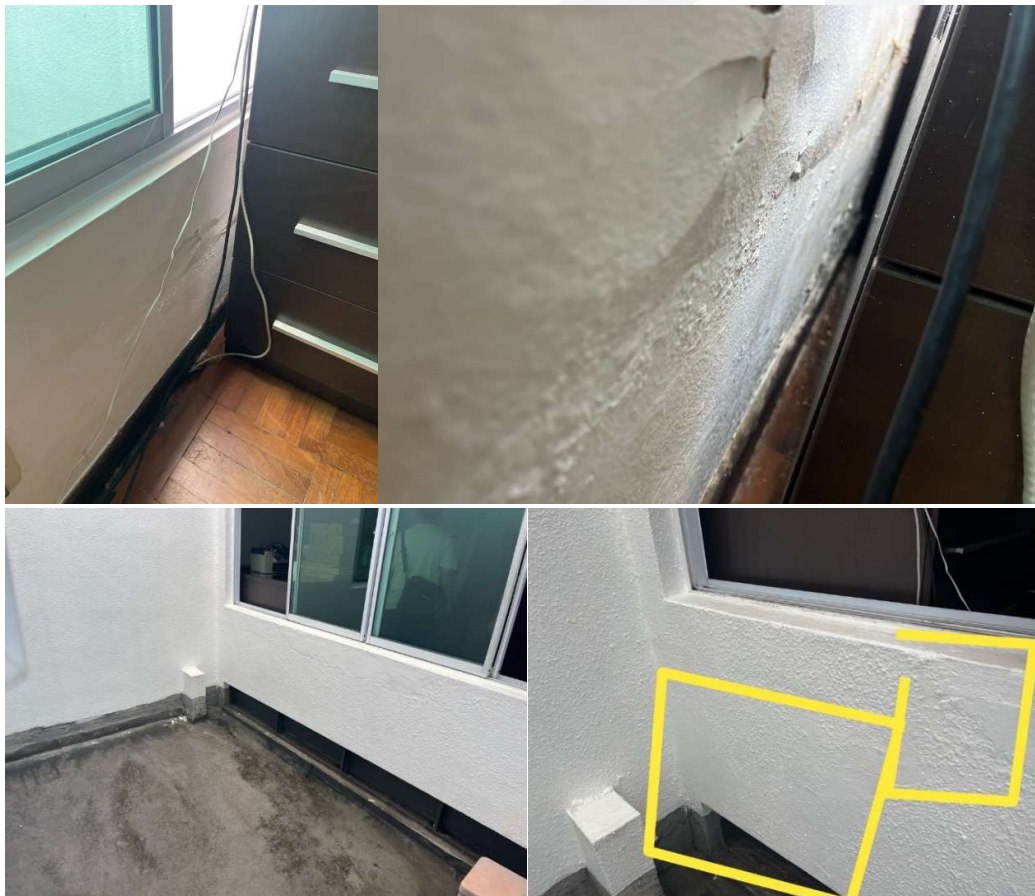
Plate 3 – Seepages in airwell

3.5.1. Symptoms of water ingress and retention could be observed across plastered surfaces immediately adjacent/ beneath the airwell, likely as a result of seepages through the airwell deteriorated waterproofing. Such symptoms include paint deterioration, water marks and algae formations. The units where these were noted were Block B units 02-16 and 02-20. See Plate 3.

3.5.2. Application of new waterproofing membrane is recommended to be carried out as it was proven to be effective in addressing the seepage – of 39 units where such rectification works were carried out, most units (36 units) did not report recurring seepages. The 3 units with recurring seepages could possibly be due to further seepages from the airwell waterproofing membrane. It is noted that the previous waterproofing applied was a liquid-applied system, which is less durable than a torch-on waterproofing membrane.

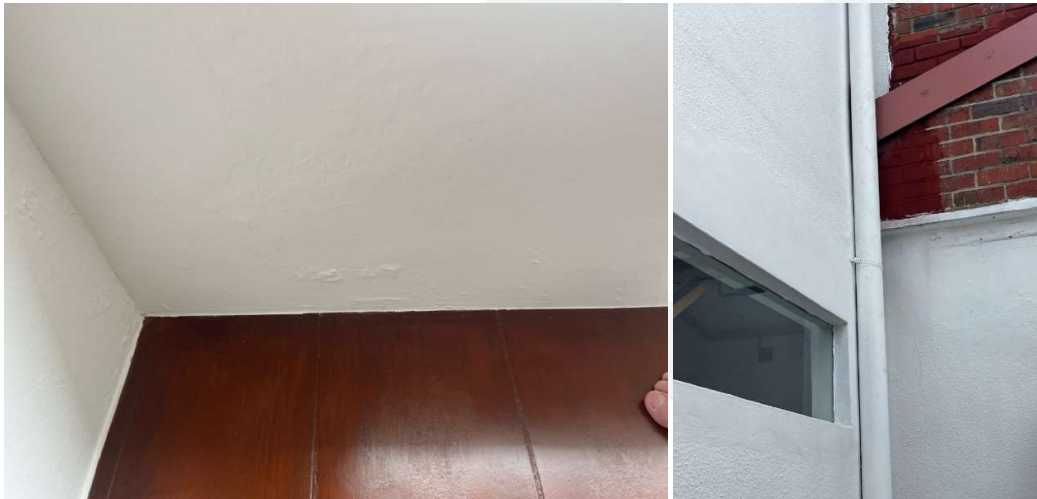
Plate 4 – Paint deterioration on interior walls facing front/rear elevations

3.6.1. Water marks and paint deteriorations could be observed across the interior plastered walls for the following units: Block A unit 02-04; Block B unit 02-20; Block C unit 02-16, and Block D unit 02-15. See Plate 4.

3.6.3. For the units with reported seepages – seepages have likely occurred through cracks, and/or debonded/ deteriorated plasterworks across the plastered walls. For areas with fair-faced masonry walls, the symptoms observed alludes to seepages through deteriorated/ degraded mortar joints and/ or deteriorated/ degraded brick surfaces. Necessary repairs to the plastered/ masonry wall ought to be carried out as detailed in the subsequent sections.

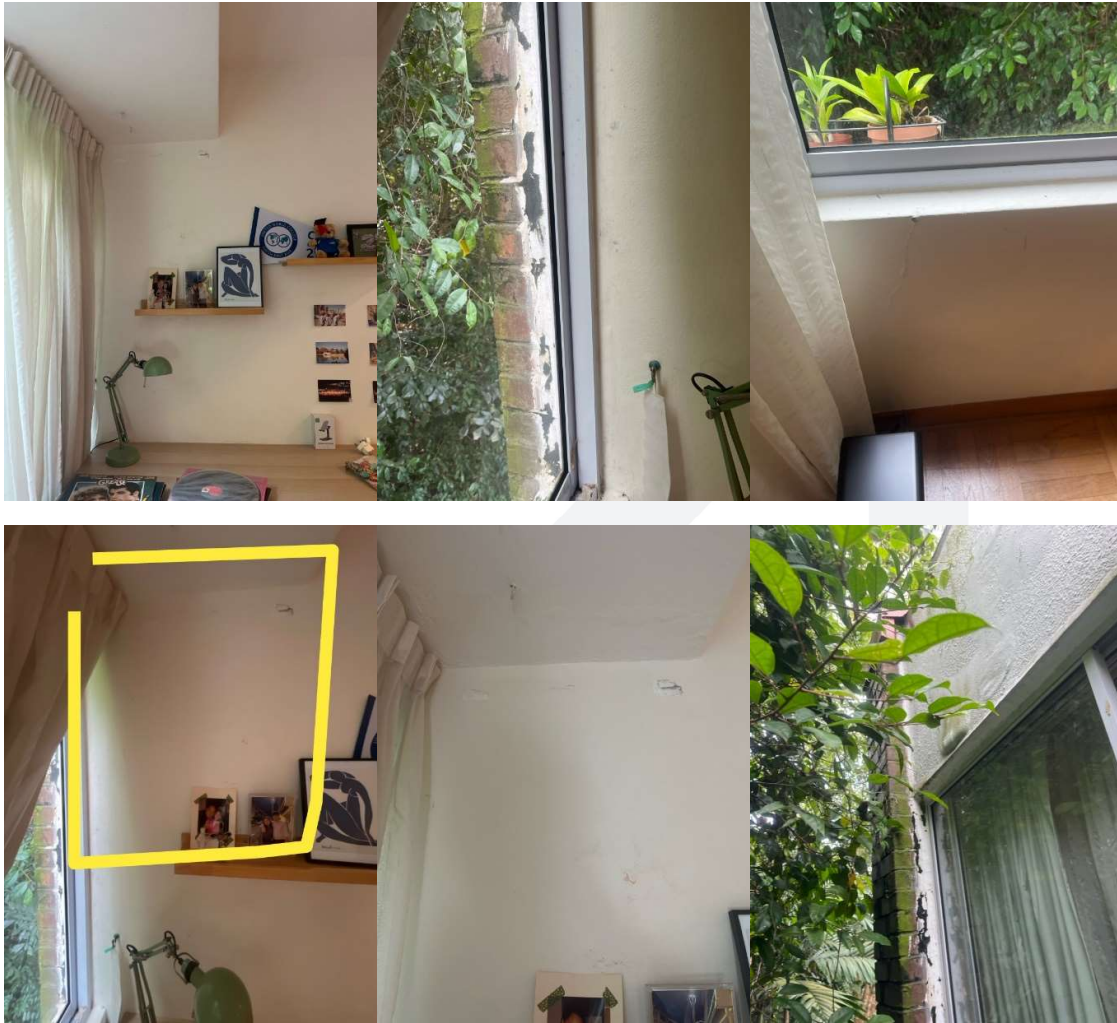
Plate 5 – Seepages on wall near to windows at Block B02-20

3.7.1. Water marks and paint deteriorations could be observed across the interior walls adjacent to the windows for the following units: Block A unit 02-04; Block B unit 02-20; Block C unit 02-16. The symptoms observed strongly suggests that the window sealant joints (frame-to-wall joints) have deteriorated, thus resulting in water seepages and retention along the sealant joints. See Plate 5 and Plate 6.

frame-to-wall joints to arrest any seepages along the sealant joints on an ad hoc basis. Such rectification works was generally effective. Units with recurring issues were noted to be with deteriorated sealant joints as described above – re-sealant works ought to be carried out to arrest any seepages.

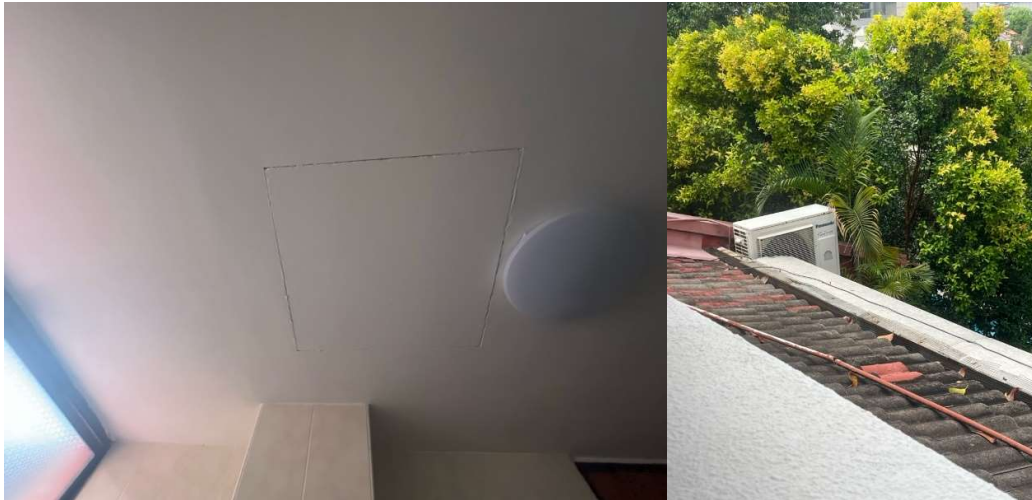
Plate 7 – Typical photo of seepage through flashing previously

- 3.8.1. While several units did highlight facing recurring seepages through roof tiles and flashing via the water seepage survey forms, visual survey into these units did not find evidence of such active recurring seepages. It is thus likely that the re-waterproofing works to the clay roof tiles/ flashing joints arrested any seepages. The rectification works carried out were thus noted to be effective. See Plate 7.

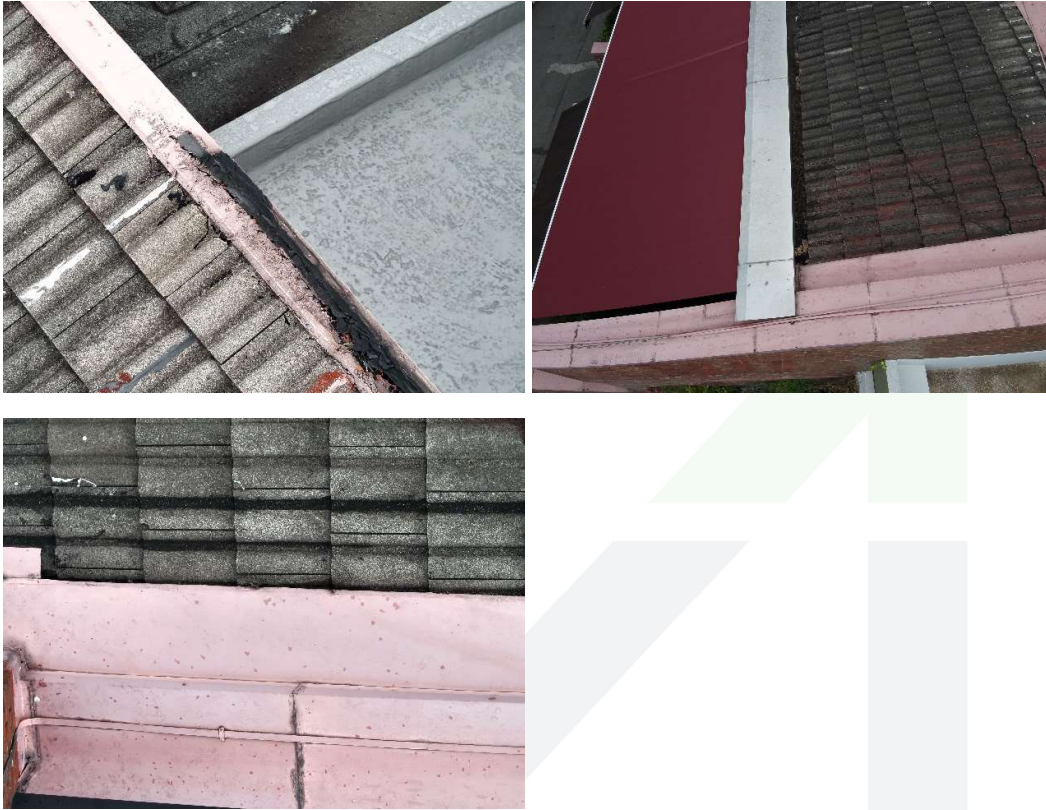
Plate 8 – Typical photo of flashing joints deterioration

- 3.10. The visual inspection carried out to the units as discussed in the earlier section was limited to survey carried out from vantage points. In addition to such visual surveys from vantage points, inspections were carried out using drone to the masonry wall façade, flashing, roof tiles and gutters to assess the general condition of these elements. Key findings of the drone inspection were summarised as follows:
- 3.11. The roof flashings were in generally deteriorated conditions, with deteriorated sealant joints noted across the flashing-to-flashing joints, and along the flashing to roof tiles joints - these sealant works were noted with extensive algae formation/ water marks

which alludes to water ingress and retention along such sealant joints. See Plate 8. In the event whereby the defects are left untreated, seepages through the flashing joints could eventually occur.

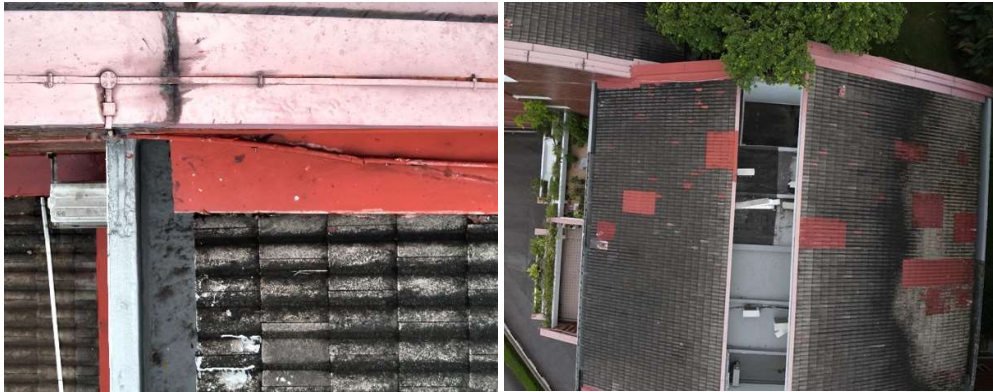
Plate 9 – Typical photos of flashing area treated previously

- 3.12. Several of the flashing joints (flashing to flashing/ flashing to roof tiles) were observed to have been waterproofed, likely as part of previous ad-hoc repair exercises. Typical photos were shown below in Plate 9. The repaired areas/ sections were noted to be of generally good condition- there were no evidence of water ingress or retention noted. Further, where such waterproofing works were carried out, there were no evidence or reports of seepages into the units beneath, which suggests that such works were effective.

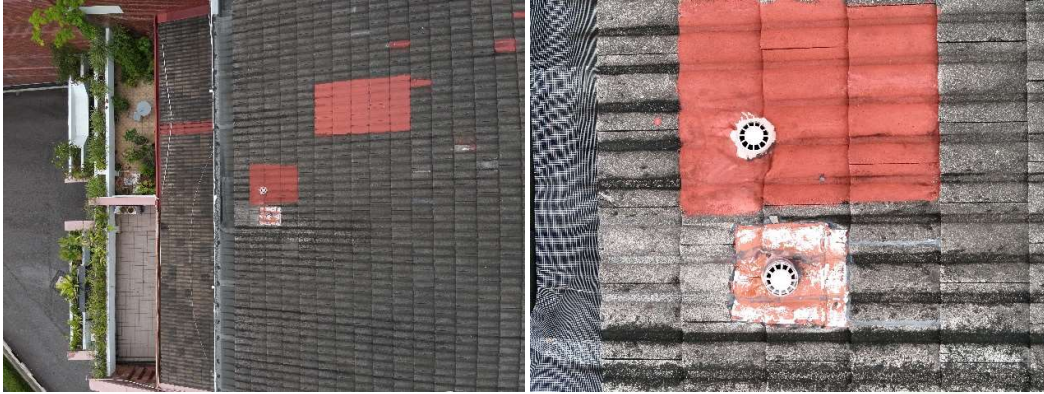
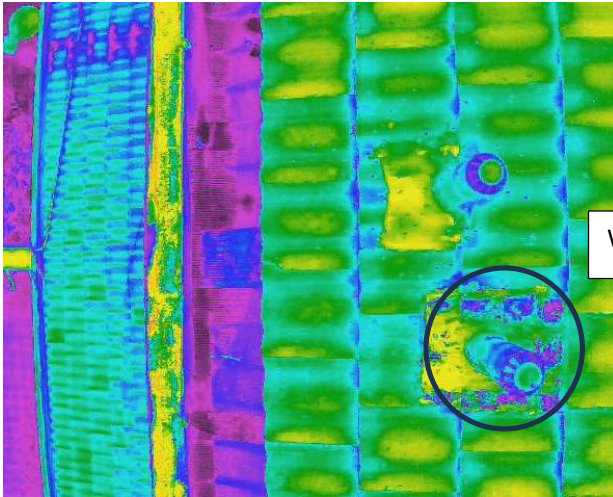
Plate 10 – Water entrapment in roof tiles/airvents

- 3.15. Visual photos and infrared thermograms taken of the roof tiles strongly suggest possible weaknesses across the tiled roofs joints, including tile to tile joints, and joints between the roof tiles and services (e.g. vent pipe) penetrations. The clay roof tiles were observed with extensive algae formation and worn coating which suggests water retention within the clay tile material. Left untreated, any further deteriorations could lead to future seepages through such joints, and/or through the tiles with increased deterioration / porosity of the clay tile. See Plate 10.

- 3.16. Various localised patches of waterproofing were noted to have been carried out across the roof tiles, and along the air vent to roof tiles joints. Such previously applied waterproofing were generally noted to be in excellent conditions - there were no evidence of water ingress or retention noted. Further, where such waterproofing works were carried out, there were no evidence or reports of seepages into the units beneath, which suggests that such works were effective.

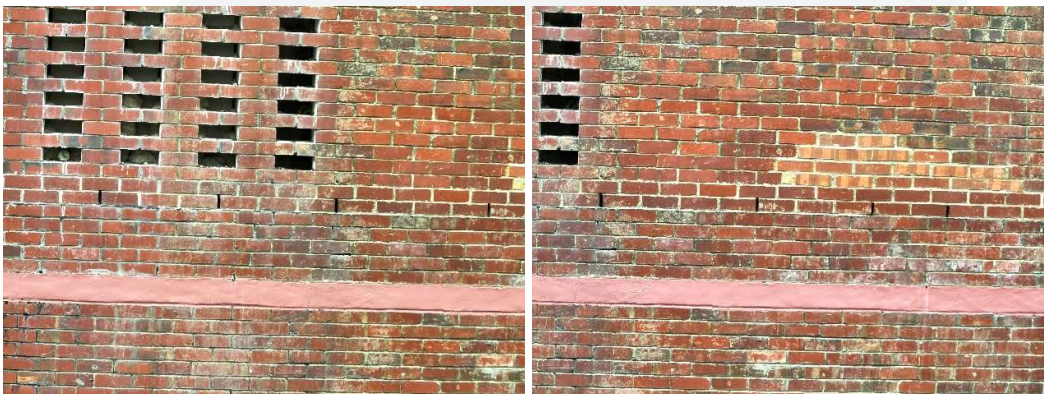
Plate 11 – Typical weep holes found on gable end walls

3.17. Across the gable end masonry wall façade, weep holes could be observed above the location of the interior floor slab. The weep holes were generally noted to be five (5) courses of bricks above the floor slab level. See Plate 11.

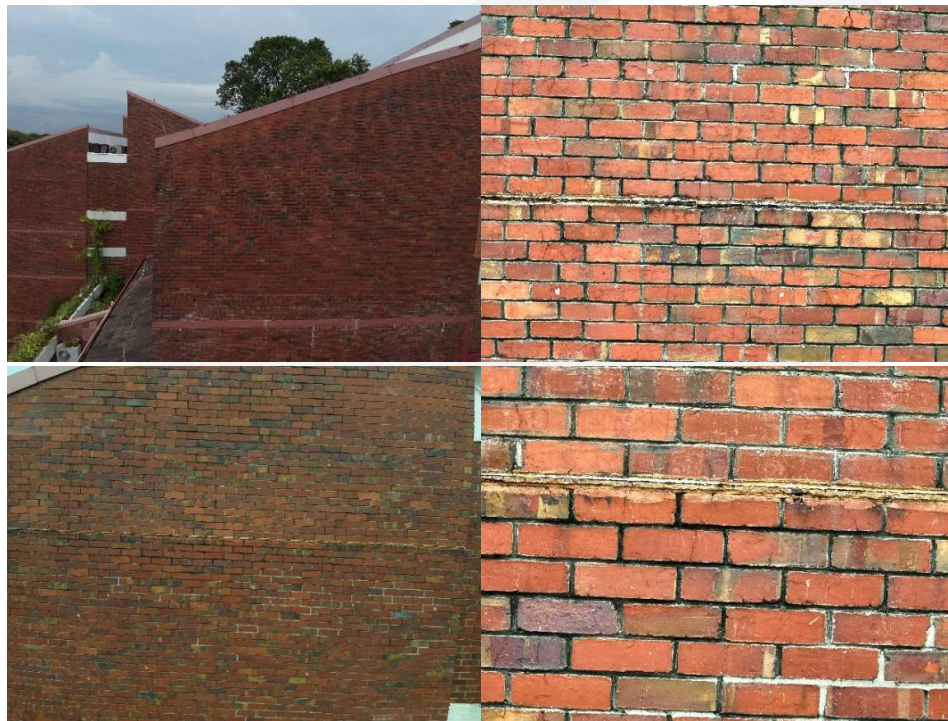
Plate 12 – Close up photo of metal plate within gable end wal

- 3.19. A metal plate could be observed immediately above the weep hole channel at random locations. It is unclear what the purpose of this metal plate was. See Plate 12.

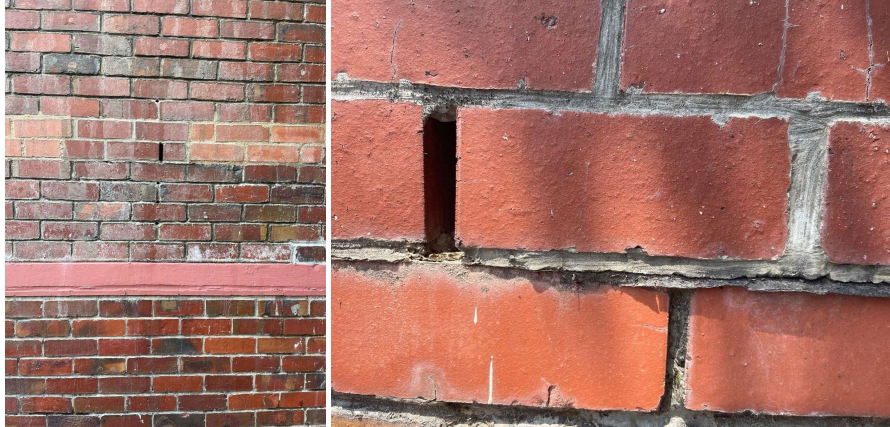
Plate 13 – Close up photo of the waterproofing membrane below weep holes

- 3.20. It is further noted that a double course of bricks immediately above the weep hole channels were generally bricks that appeared to be newer - These bricks were generally observed to be relatively well-fired and homogeneous in colour. The presence of such newer bricks, at random locations across the gable end façade, strongly suggests that latter-day repair works may have been carried out to the weep channels. Waterproofing membrane was also observed below every weep hole row on the façade. See

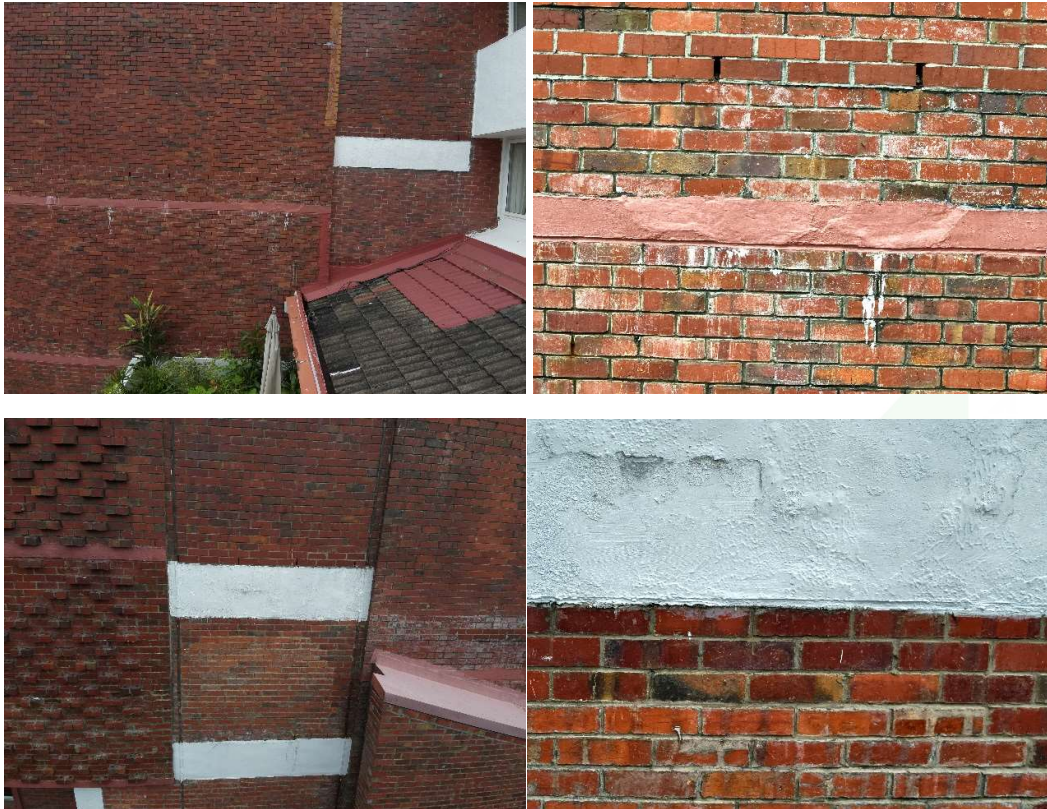
Plate 15 – Efflorescence formation below weep holes

- 3.22. Visual and infrared thermograms taken of the weep channel strongly suggests that the weep channel may not be performing or functioning as intended. Key observations made were summarised as below:
- 3.23. Efflorescence formation, water marks and degraded surface coating could be observed beneath the weep hole channel, which alludes to water seepages through the deteriorated weep hole channel in a downward manner. Similar symptoms of seepages could also be observed along the floor slab to masonry wall joints. See Plate 15

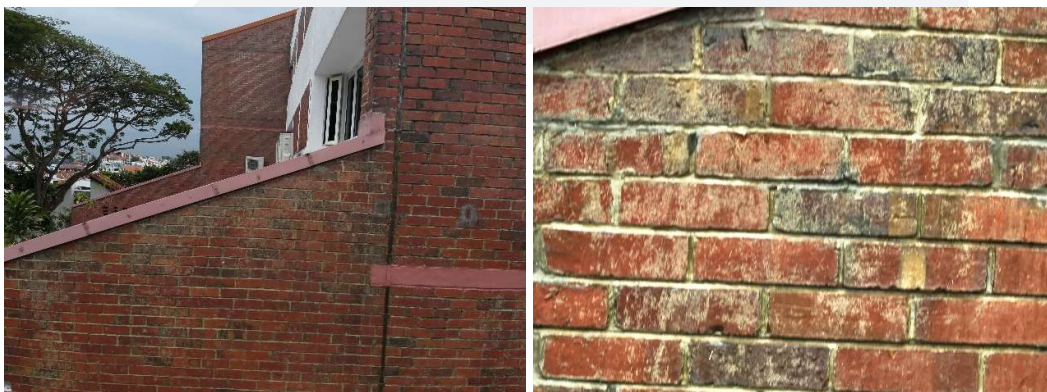
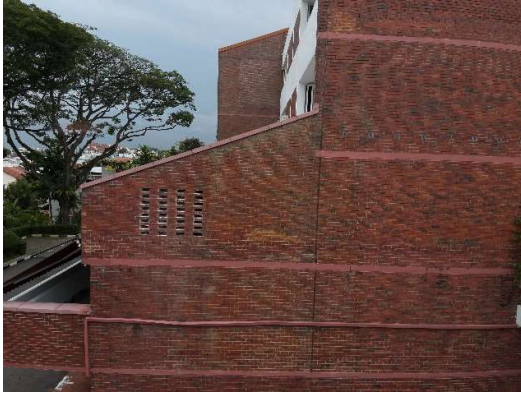
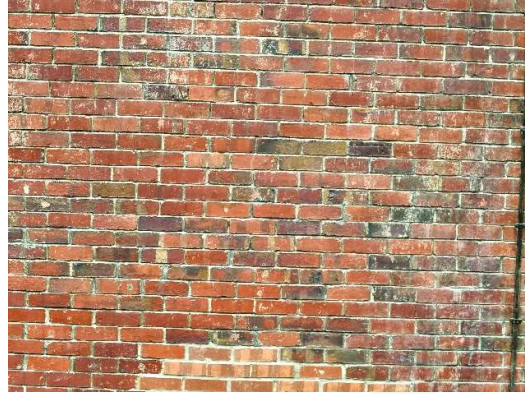
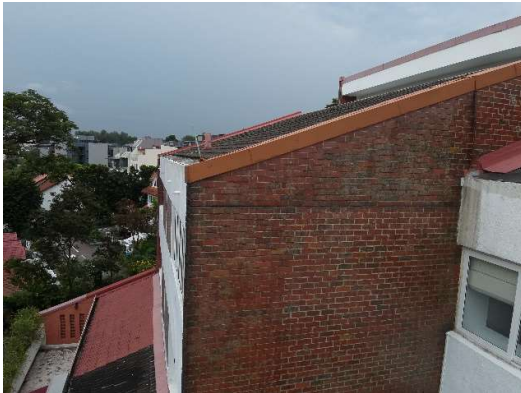
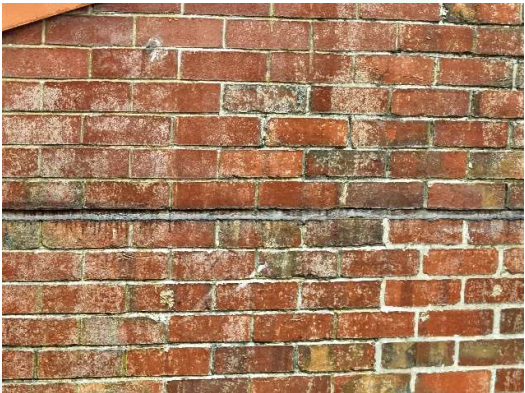
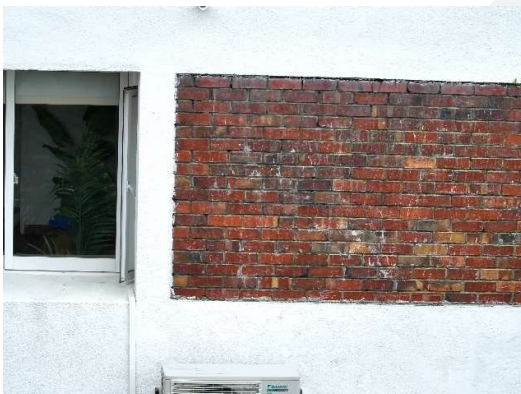
Plate 16 – Degraded coating on brick surface

3.24. The gable end masonry wall was noted to be with widespread surface degradations, which includes cracks, deteriorated mortar joints, along with efflorescence formations, algae formation and water marks across the wall. Additionally, the surface coating along the brick surface was observed to be worn, with signs of adhesion failure, discoloration and water marks. See Plate 16

- 3.25. The symptoms observed herein strongly alludes to water retention within the gable end masonry walls. While an acrylic coating had previously been applied to the wall, likely to arrest such seepages, such a coating was noted to be deteriorated and degraded. Such deterioration/ degradation could possibly have occurred as a result of wear and tear of the coating. Additionally, cracks across the masonry wall, and deteriorated mortar joints, could be observed extensively across the masonry walls.

- 3.26. Such cracks and deteriorated mortar joints, along with the deteriorated surface acrylic coating, would have allowed water to seep through and retain within the cavity. Entrapped water within the cavity wall may trickle down slowly along the inner face of the wall and would over time saturate the capillary pores of the surrounding bricks. Water entrapped within the cavity would also result in the saturation of vapour moisture within the cavity wall. Such saturation of the vapour and/or liquid moisture could potentially result in the failure/ degradation of the surface coating due to adhesion failure between the brick surface and surface coating of the brick wall. Such adhesion failure would lead to further degradation of the surface coating, which leads to a vicious cycle where the coating would experience accelerated degradation with time.

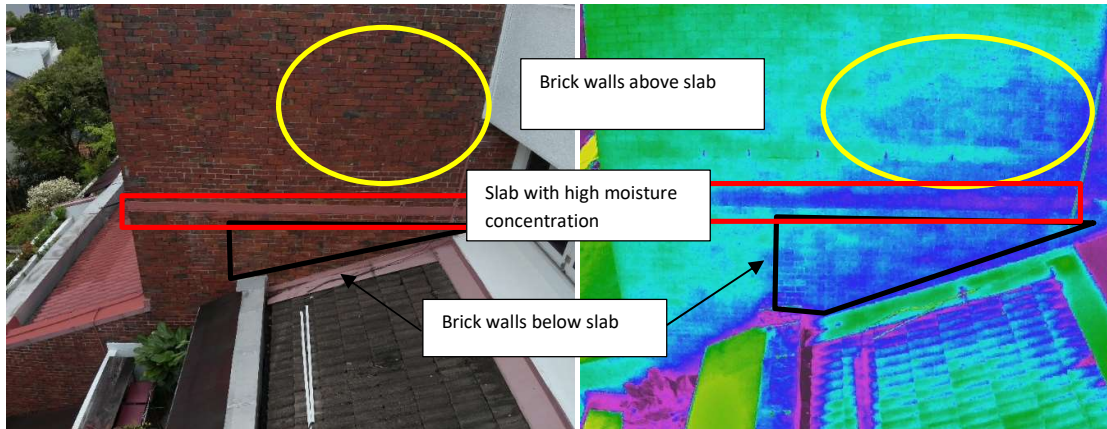
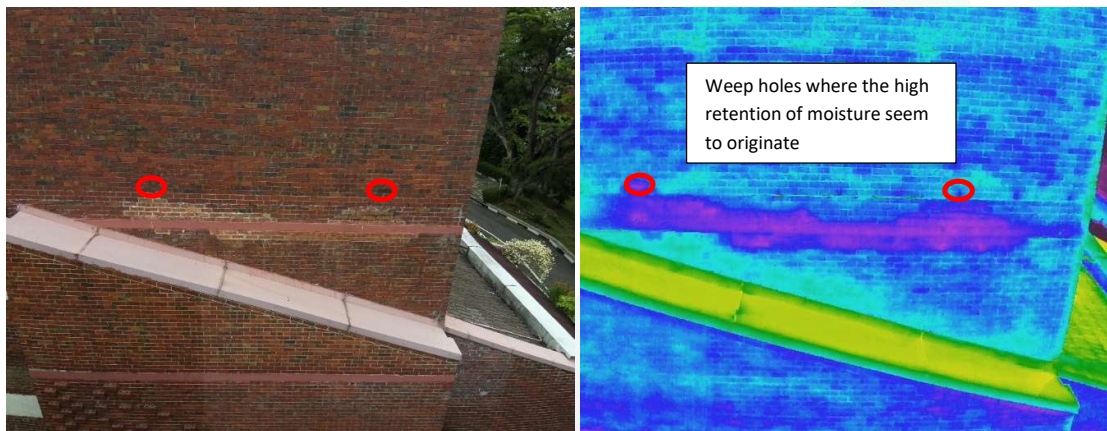
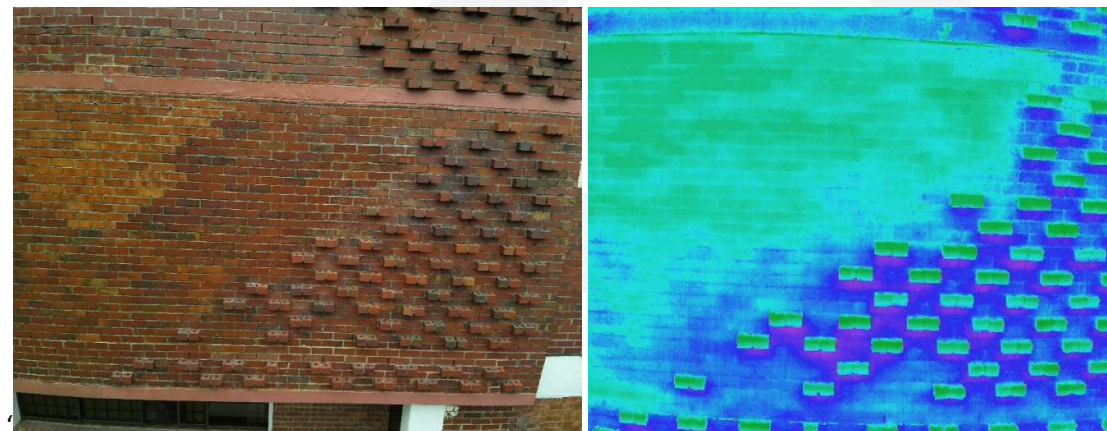
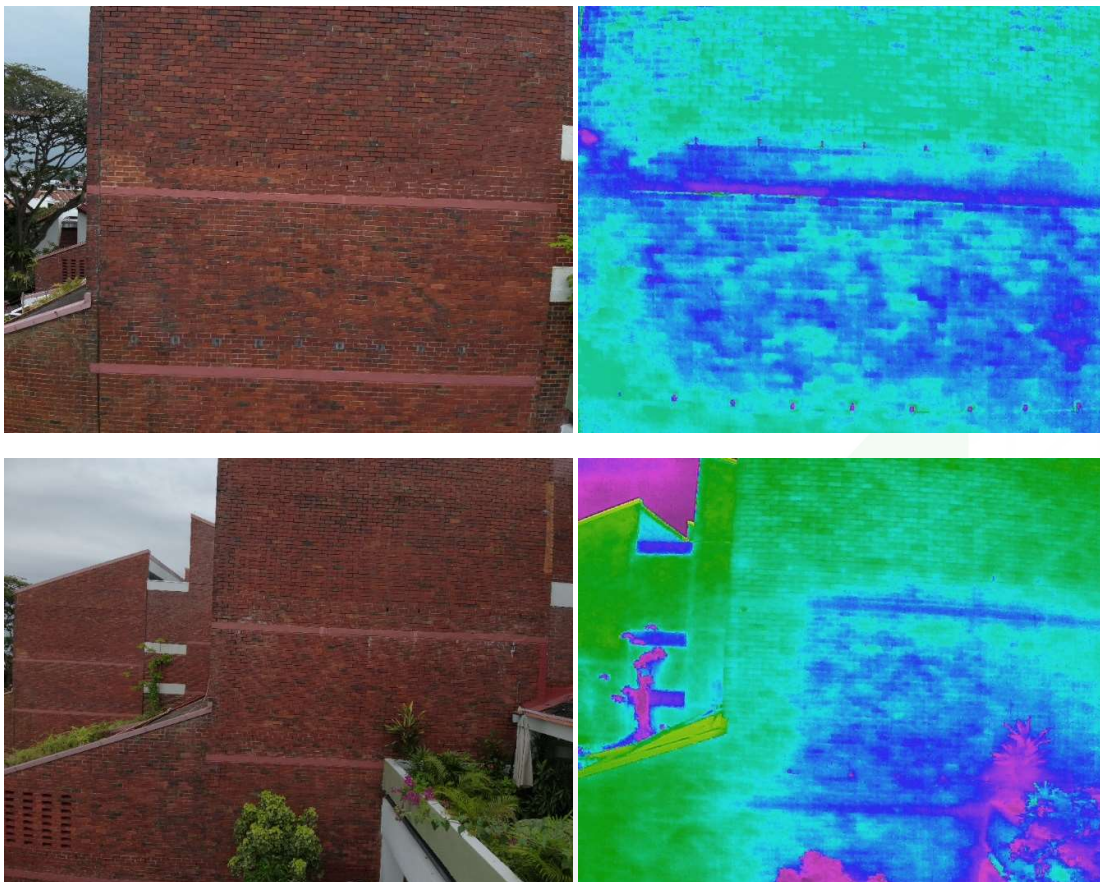
Plate 17 – Cold spots (shaded in blue) are signs of moisture retention within the brick facade

- 3.28. Infrared thermograms across the façade supports the hypothesis that water is seeping through and retaining within the cavity wall- thermograms taken showed that there are concentrations of moisture entrapped within the floor slab between levels. The brick walls above and below the slab were also noted with symptoms of water retention as indicated in the thermograms. See Plate 17 for thermograms illustration, with those in blue shade indicating presence of moisture retention.

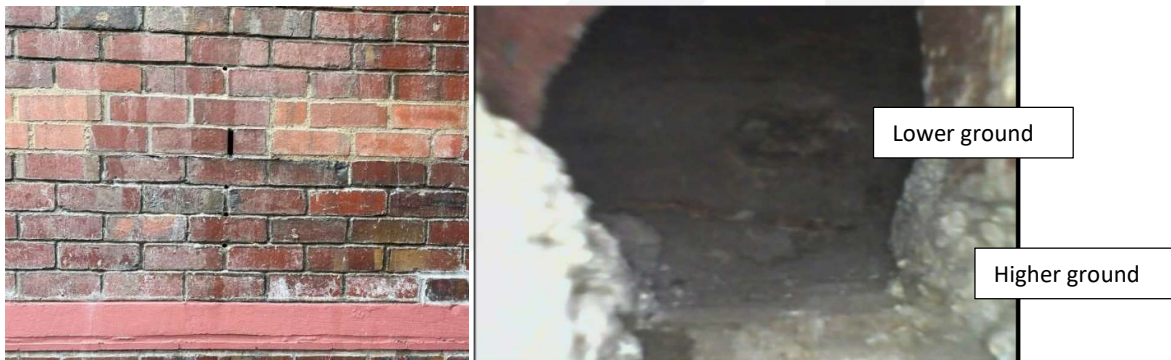
- 4.3. From videoscope images, waterproofing works had been carried out to the weep channels. This could be possibly carried out latter-day, particularly in view of the newly installed double courses of bricks observed around the weep hole channel level. Nonetheless, despite the repair works/ waterproofing works carried out, the seepages along the weep channel persisted.

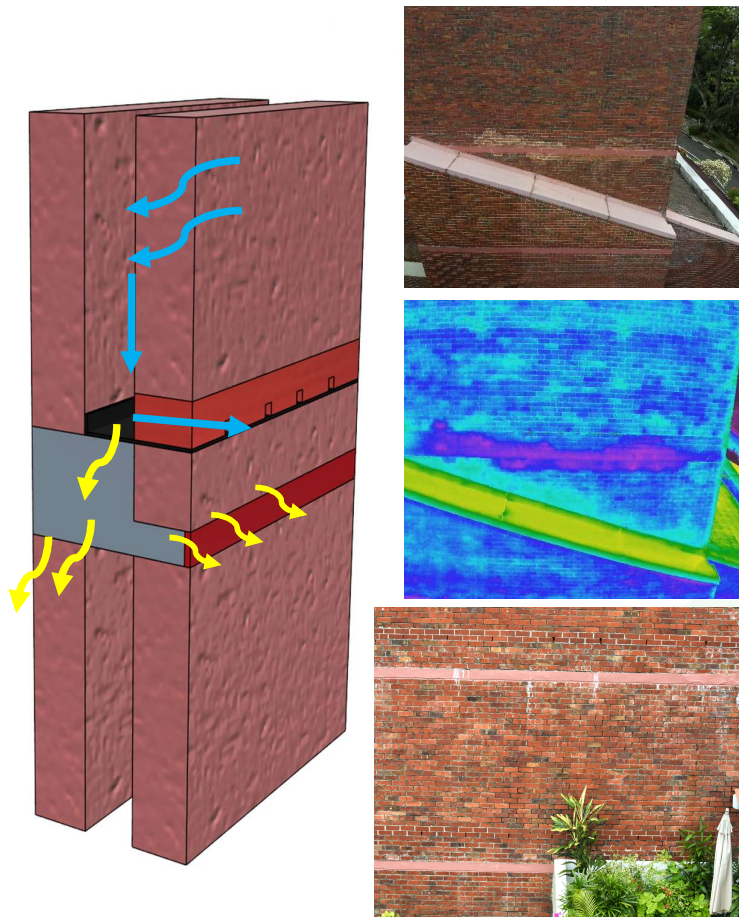
- 5.1. From our visual, thermographic and videoscope findings, the possible water seepage path through a typical cavity wall is illustrated as below.

- 5.2. Water could seep in through the exterior face of the cavity wall via cracks, debonded/ degraded/ deteriorated mortar joints and/or through the deteriorated acrylic coating applied onto the masonry wall. Other potential sources of water also includes the roofs' flashing joints.
- 5.3. Any water that have seeped through into the cavity wall would be channeled towards the weep channel. As a direct consequence of the grading of the channel, any seeped water would retain along the inner-face of the cavity wall.
- 5.4. Visual observation and infrared thermograms taken across the exterior walls suggests that the entrapped water could seep through the weep channel into the interior walls, or through the slab into the unit beneath, or through to the exterior wall beneath the weep channel.
- 5.5. A water spray test was carried out to confirm the hypothesis.

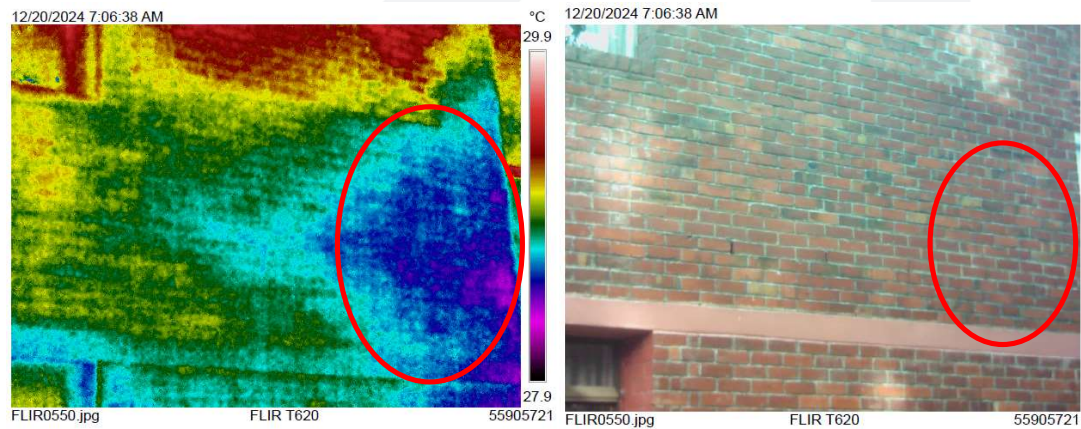
Plate 22 – Thermogram showing moisture retention on wall at where original weep holes are at

6.2.2. For the section of the masonry walls with weep holes, evidence of moisture retention across the wall could be observed as evidenced by the cold spots noted. See Plate 22.

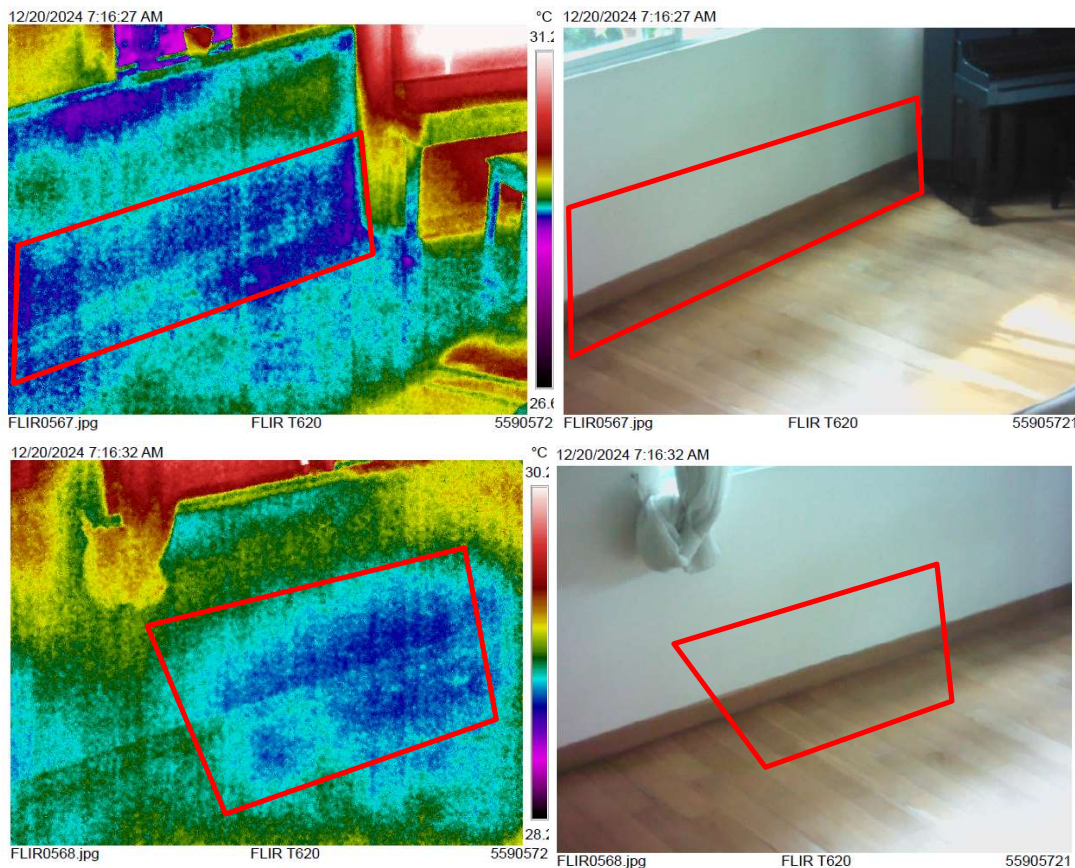
Plate 23 – Thermograms of living room (before spray test)

6.2.3. Thermograms on the internal living room showed moisture retention along the bottom of the wall and skirting, indicating likelihood of seepage from the external gable end wall. See Plate 23 for moisture retention areas on thermograms

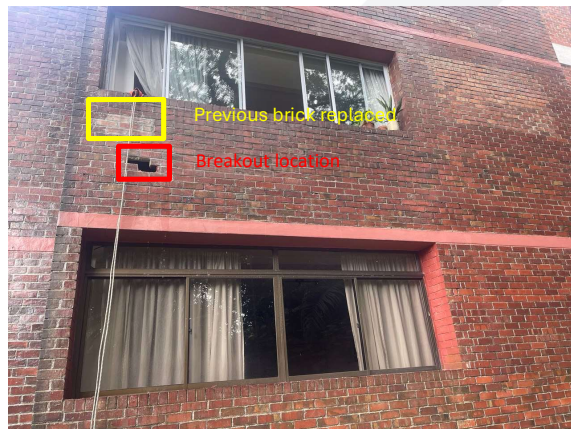
Plate 27 – Breakout inspection location

- 6.3.1. Testing results for the water spray test were inconclusive as there was no significant increase in moisture levels detected within the unit after the water spray test.
- 6.4. In light of the above, a second spray test and tactile survey was arranged on 9 Jan 2025. A breakout inspection was also carried out to the weep channel to confirm the construction details of the weep channel. This breakout inspection was carried out to the left end of the gable end wall as shown in Plate 27. Latter-day installed weep pipes could be observed for this section.

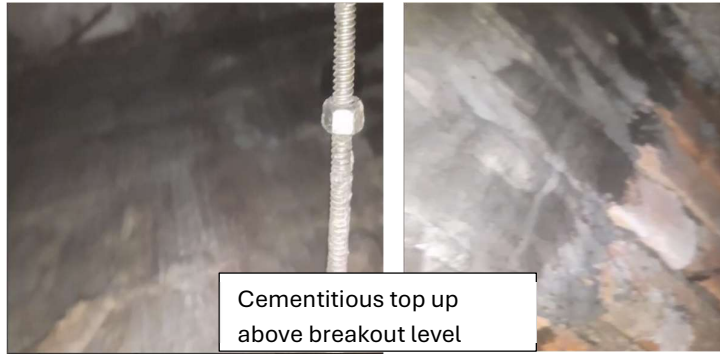
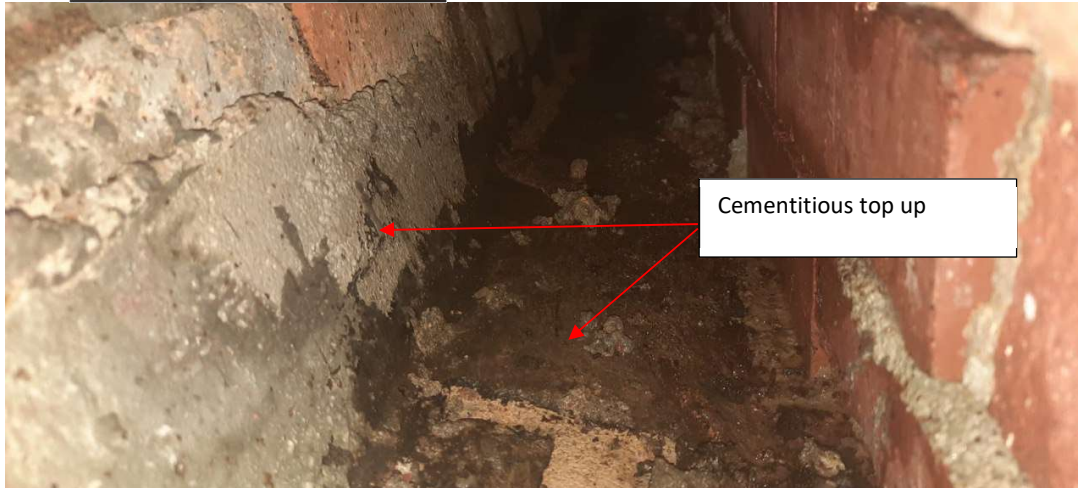
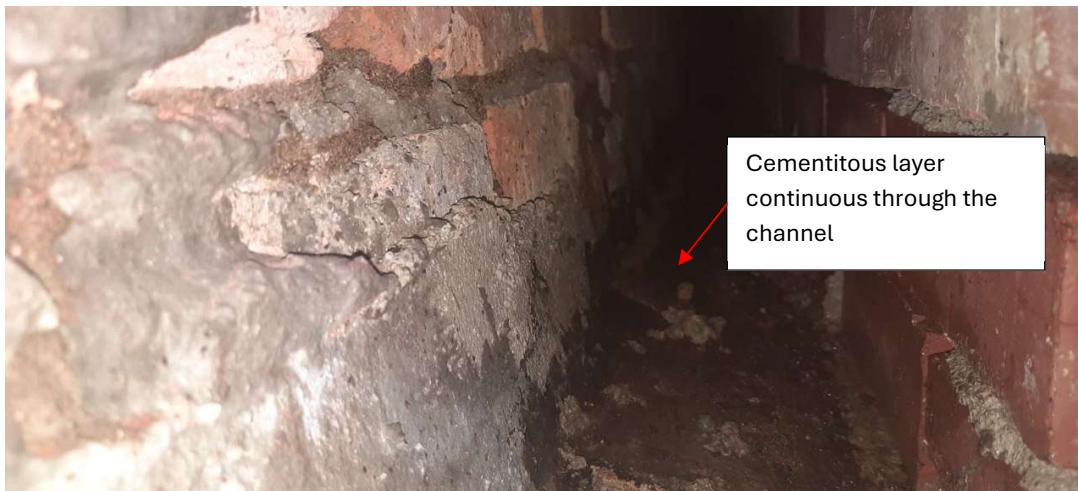
Plate 28 – Photos of the cavity wall within breakout location

- 6.4.1. Similar to what was observed during the videoscope inspection, a cavity wall could be observed within the gable end wall. Notably, a cementitious layer had been applied across the walls of the weep channel. This cementitious layer appeared to be a latter-day addition. It is highly likely that the area of replaced bricks above the breakout area was previously opened to facilitate the application of this cementitious layer. See Plate 28 for photos within the breakout area. An illustration is shown in Plate 29 showing the extent of cementitious top up within the cavity.

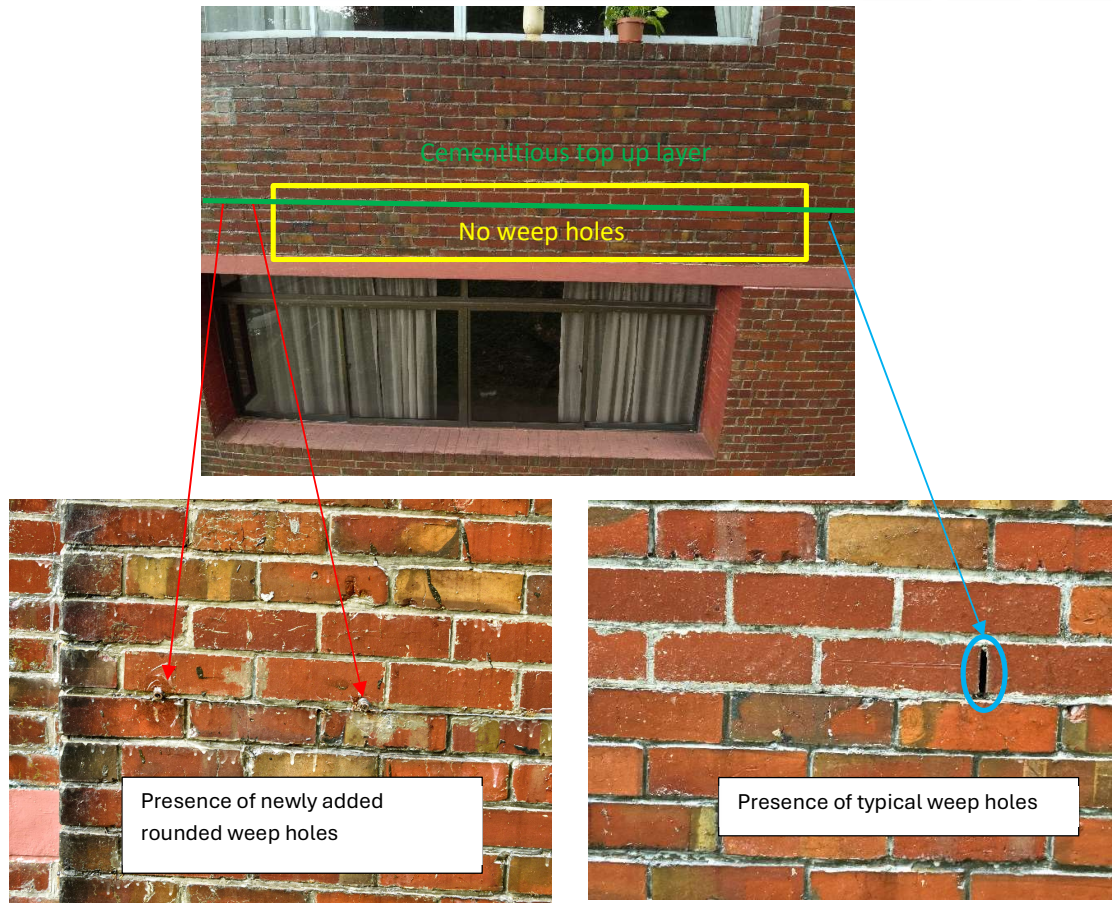
Plate 30 – Illustration of position of weep holes and top up layer found in cavity wall

6.4.3. The close up and breakout inspection revealed that the weep channel has likely been re-levelled. Given that the new weep pipes were higher than the typical weep holes, a re-levelling work had likely been carried out to ensure increased gradient to discharge any surface runoff within the weep channel. See Plate 30. Such works were likely carried out together with the application of cementitious layer to the cavity walls. The cementitious layer noted could possibly be a waterproofing layer.
