Report on Water Seepage Investigation at Island View

MCST 1131

Integraal Building Consultancy and Services Pte Ltd

24 January 2025

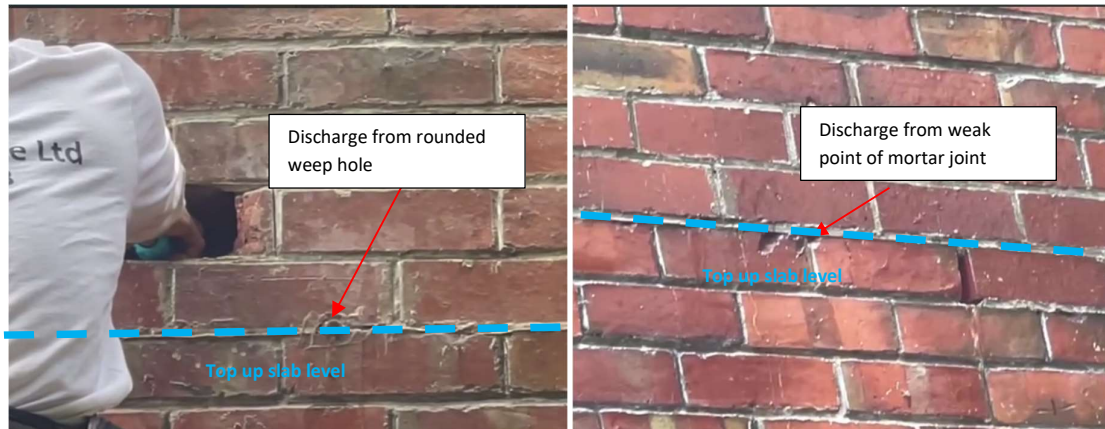
Plate 31 – Location of discharge water on façade during water spray test

- 6.5. Water spray test was next carried out to the cavity wall to simulate water ingress into the cavity. During the course of water spray test, it was observed that water was able to discharge through the latter-day added weep pipes, and through the weak/deteriorated mortar joints across the brick walls. See Plate 31. No water was noted to be discharging from the original weep holes.
- 6.6. Observation from the water spray test appeared to confirm the hypothesis given under sub paragraph 6.4.3 where the weep channel was likely re-levelled. Instead of providing a smooth gradient, it is likely that a layer of cement equivalent to the thickness of a brick row were added. With the addition of this cementitious layer, the original weep holes had likely been sealed off. New weep pipes had been added to facilitate draining of water through the weep channel.

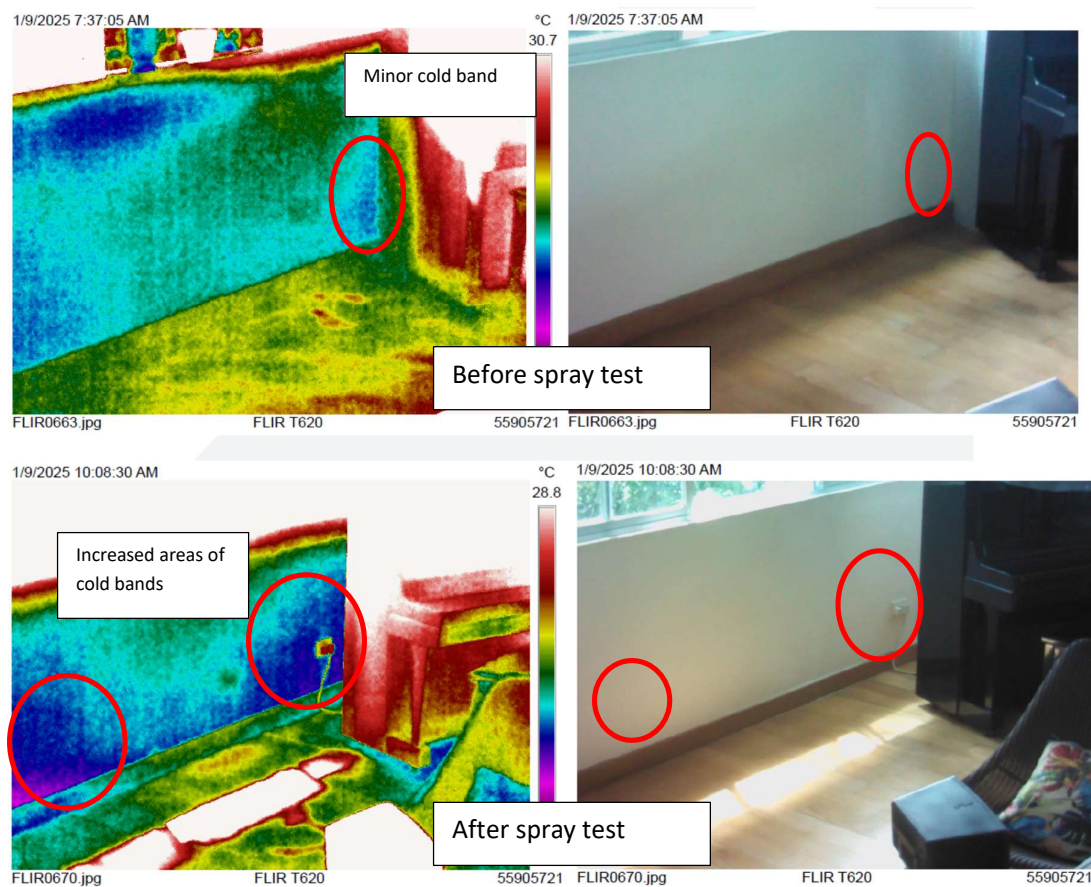
Plate 32 – Before and after thermograms in living room

- 6.7. Within one hour of spraying, infrared thermograms showed an increase in moisture distribution along the base of the wall and along the skirting. See Plate 32 and Plate 33 for thermograms showing the difference in moisture distribution before and after spray test.

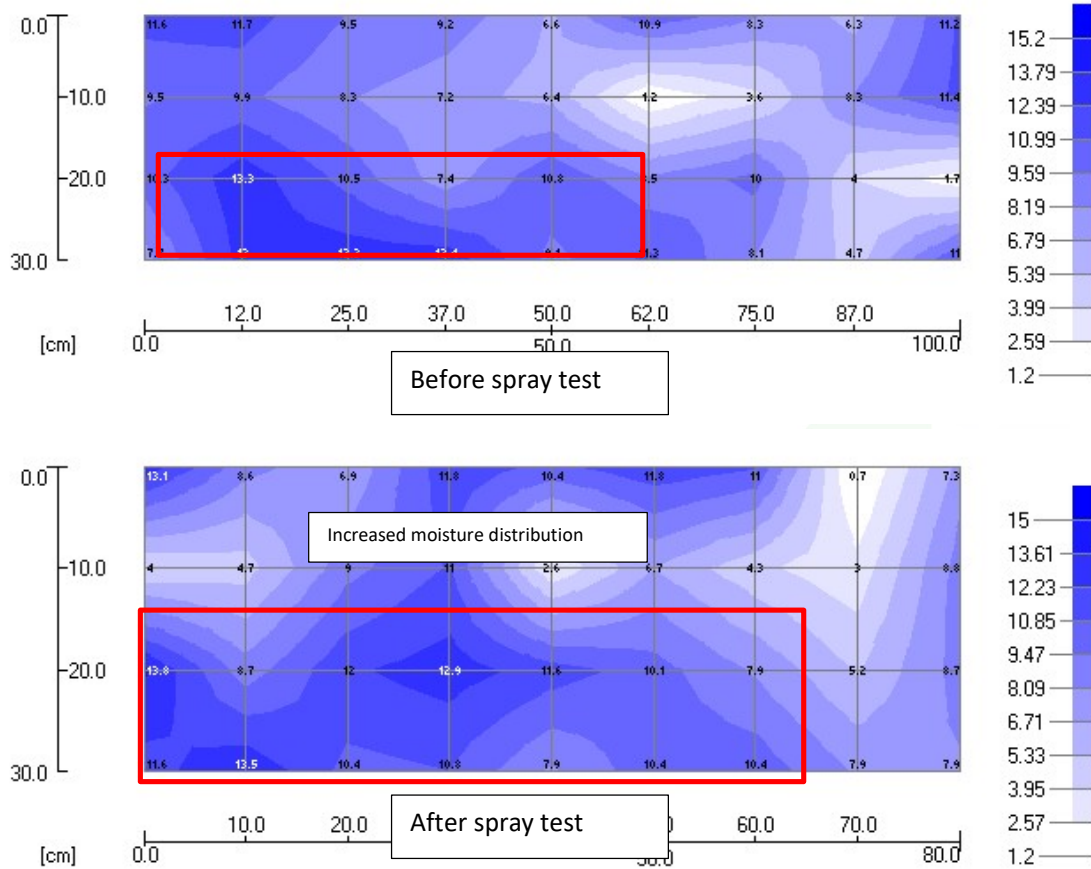
Plate 34 – Before and after microave tomograph on wall

- 6.8. Results from microwave moisture tomography also showed a slight increase in moisture distribution along the living room wall. See Plate 34 for comparison of before and after microwave moisture results.

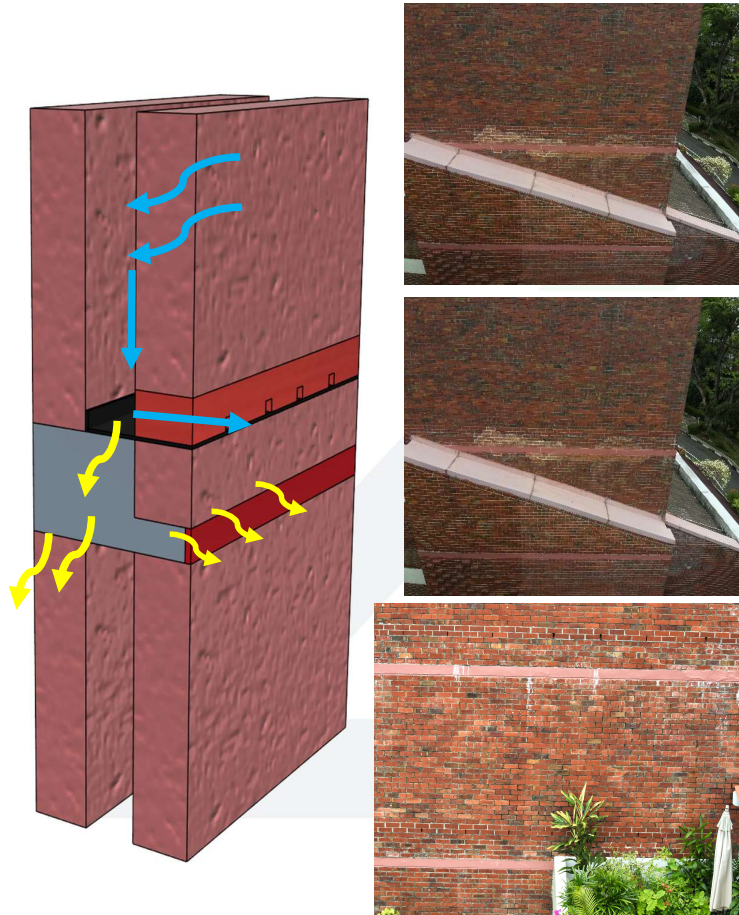
Plate 35 – Illustration of seepage path

- 6.10. As a result of wear and tear/ deterioration of the weep channel waterproofing and likely poor levelling (inefficient discharge), water could seep through any weaknesses across the weep channel into the interior walls, or through the slab into the unit beneath, or through to the exterior wall beneath the weep channel.
