Report on Water Seepage Investigation at Island View

MCST 1131

Integraal Building Consultancy and Services Pte Ltd

24 January 2025

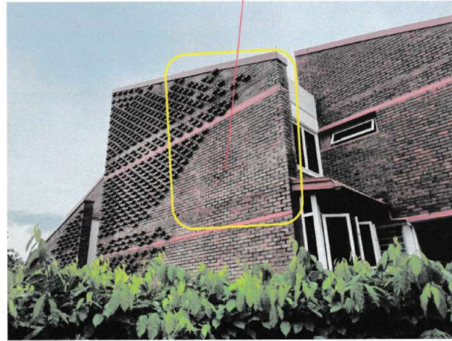
Blk 38C #02-16 External wall apply 3layer system

a. Seepage at bottom of gable end wall

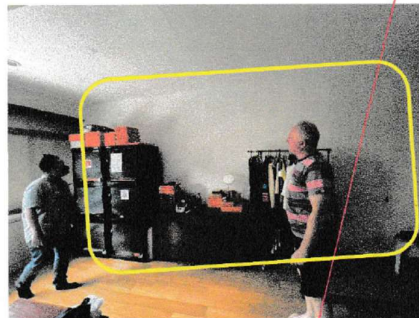
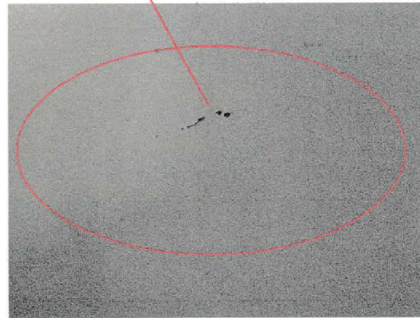
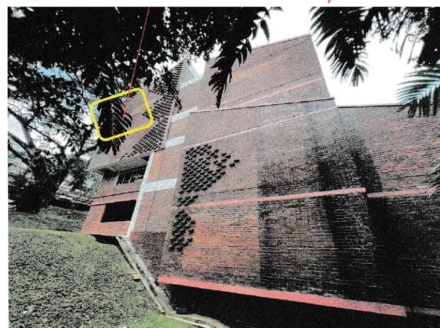
Blk A #02-03 Children's bed room outside external wall apply 3layer

b. Seepage at middle of gable end wall

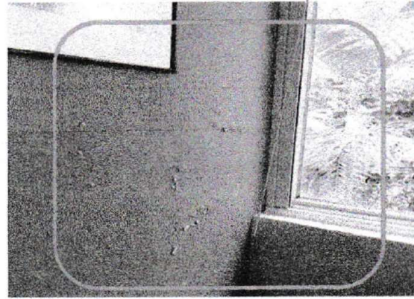
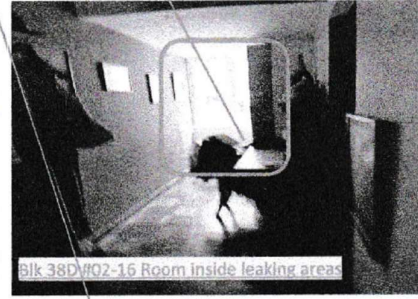
d. Seepage near window

Waterproofing treatment work at Blk 38D #02-16 children's bed room outside external wall facing backyard areas (Refer photos)

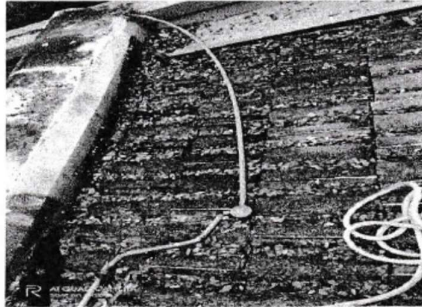
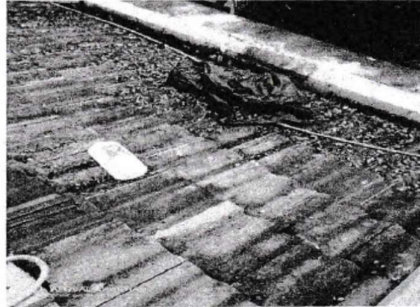
e. Roof flashing

Waterproofing treatment to Blk 38C #02-03 level 2 Balcony flashing & pitch roof tiles facing left side backyard area

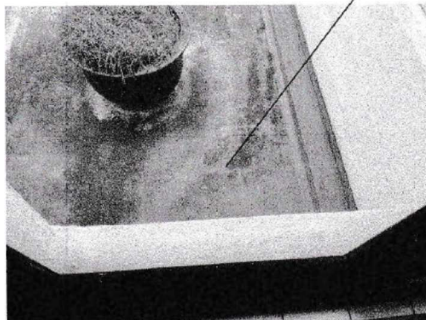
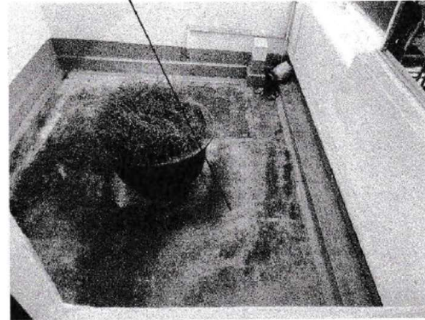
Blk B 02-20 RC Air-well apply 5layer system

f. RC airwells

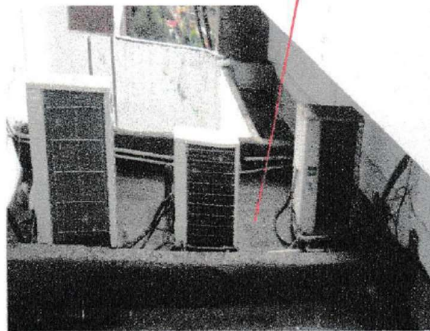
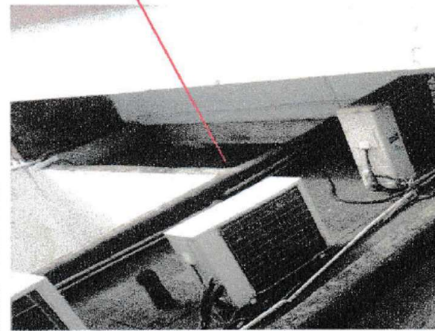
g. RC flat roof

Waterproofing treatment works at Blk 38A #02-19 to level 3 window frame entrance above RC roof and RC air-con ledge areas (Refer photos #1, #2)

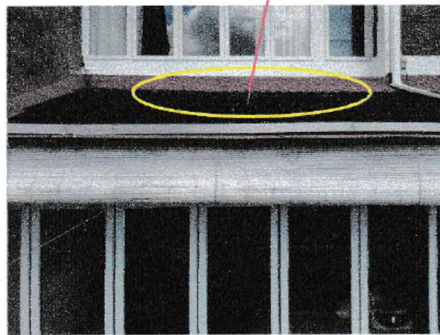
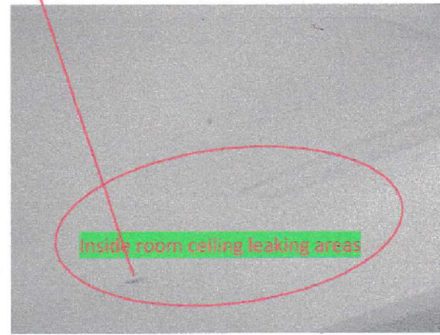
h. Roof tiles/Airvent penetration

Waterproofing treatment to Blk 38A #02-19 balcony above pitch roof tiles area (Refer photos #3, #4)

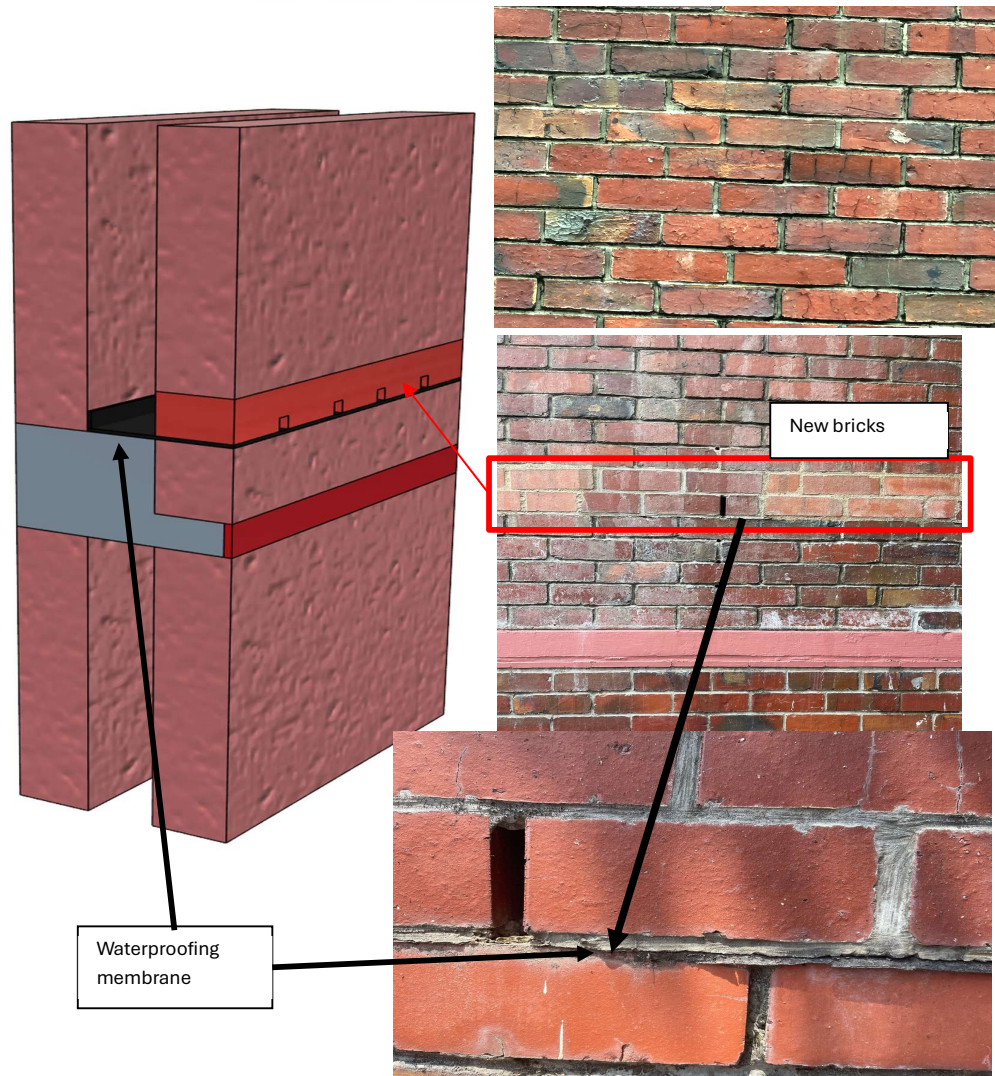
Plate 14 – Illustration of gable end wall construction details

- 3.21. From the observations made, a typical construction of the gable end masonry wall is illustrated as follows. As discussed in the preceding sections, the gable end masonry wall is designed to allow water to seep through. However, any water seeping through ought to flow down towards the weep channel and discharge from the weep holes. *The typical location where the waterproofing membrane(see sub paragraph 3.19) and the double course of bricks (see sub paragraph 3.20) may be found is included in the illustration. See Plate 14*

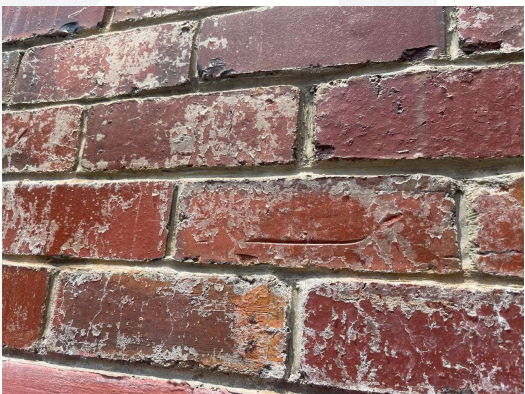
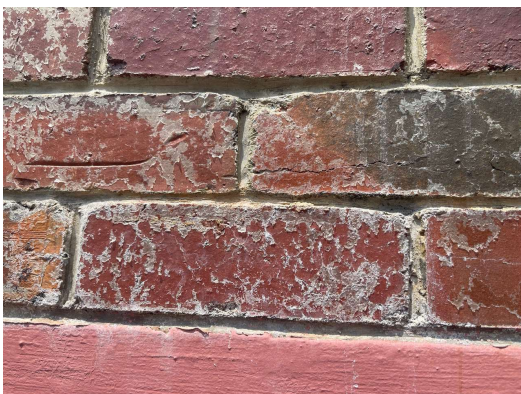
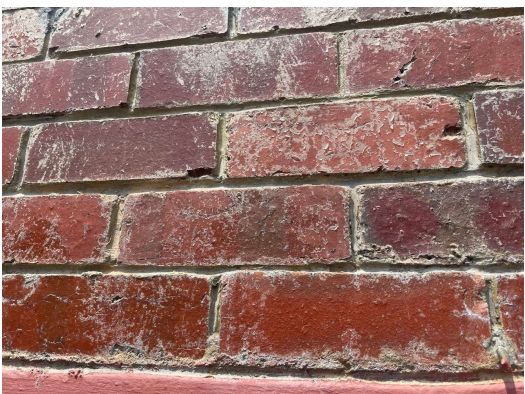
Plate 16 – Degraded coating on brick surface

3.24. The gable end masonry wall was noted to be with widespread surface degradations, which includes cracks, deteriorated mortar joints, along with efflorescence formations, algae formation and water marks across the wall. Additionally, the surface coating along the brick surface was observed to be worn, with signs of adhesion failure, discoloration and water marks. See Plate 16

- 3.25. The symptoms observed herein strongly alludes to water retention within the gable end masonry walls. While an acrylic coating had previously been applied to the wall, likely to arrest such seepages, such a coating was noted to be deteriorated and degraded. Such deterioration/ degradation could possibly have occurred as a result of wear and tear of the coating. Additionally, cracks across the masonry wall, and deteriorated mortar joints, could be observed extensively across the masonry walls.

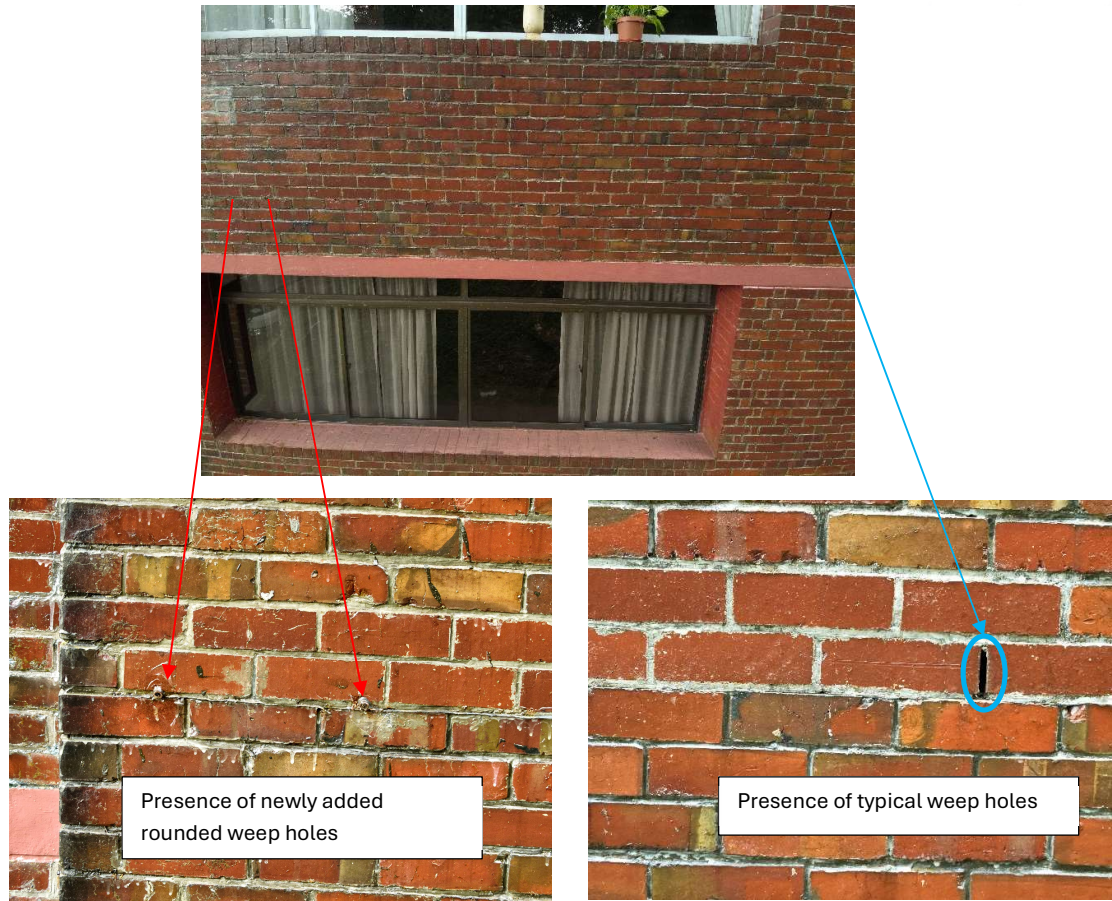
Plate 20 – Illustration of new and original weep holes locations at B02-20 gable end wall

6.1.3. A section of the façade wall outside unit 02-20 was observed with weep holes, while the remainder was observed without. The section without weep holes were noted immediately beneath the window whereas the section with weep holes was found to the right of the windows. See Plate 20 For the section without weep holes, latter-day installed weep pipes could be observed. The entire stretch of the

masonry walls were further observed to have been treated with an acrylic waterproofing coating.

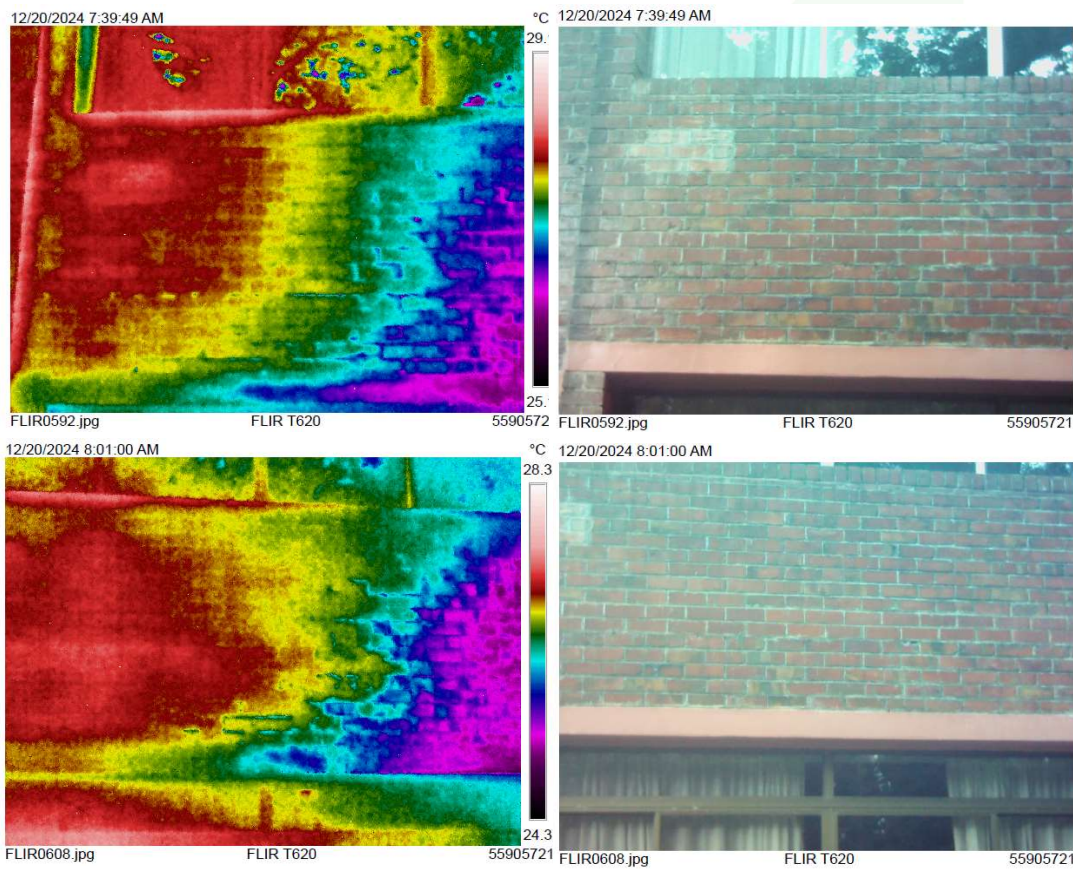
Plate 25 – Thermograms of façade after spray test

- 6.3. Water spray test was performed on the weep holes along the right side of wall to simulate water ingress into the cavity wall. See Plate 24. Thermograms were taken after 20 mins of the spray test which showed a slight increase in the cold spots observed across the masonry wall. Such a slight increase alludes to increase in moisture across the affected walls, which is to be expected given that the water spray test introduces significant water to the masonry walls. See Plate 25. There was however no significant increase in the moisture affected areas within the interior living room wall and floors. See Plate 26.

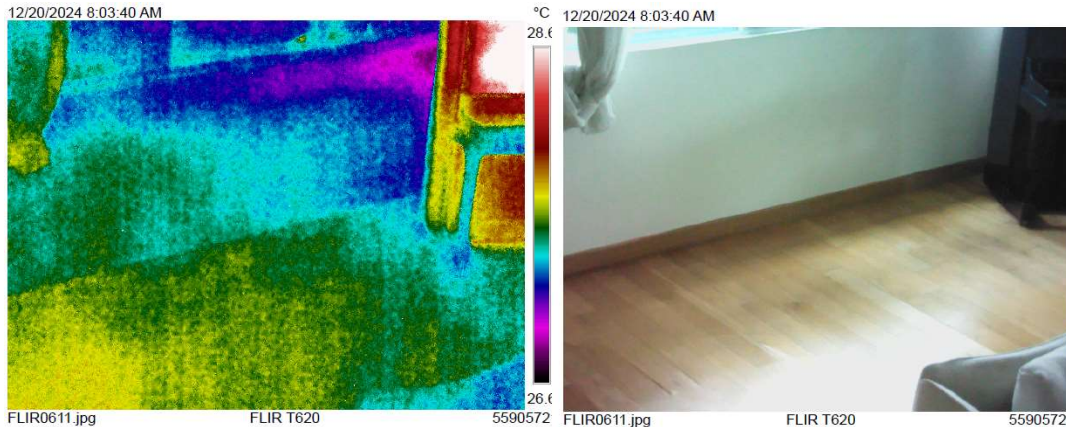
Plate 26 – Thermogram of façade after spray test

- 6.3.1. Testing results for the water spray test were inconclusive as there was no significant increase in moisture levels detected within the unit after the water spray test.
- 6.4. In light of the above, a second spray test and tactile survey was arranged on 9 Jan 2025. A breakout inspection was also carried out to the weep channel to confirm the construction details of the weep channel. This breakout inspection was carried out to the left end of the gable end wall as shown in Plate 27. Latter-day installed weep pipes could be observed for this section.

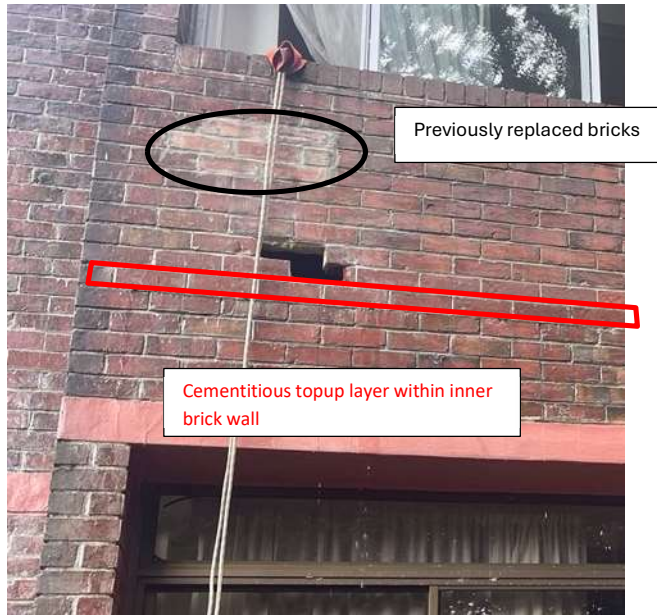
Plate 29 – Cementitious top up layer

- 6.4.1. Similar to what was observed during the videoscope inspection, a cavity wall could be observed within the gable end wall. Notably, a cementitious layer had been applied across the walls of the weep channel. This cementitious layer appeared to be a latter-day addition. It is highly likely that the area of replaced bricks above the breakout area was previously opened to facilitate the application of this cementitious layer. See Plate 28 for photos within the breakout area. An illustration is shown in Plate 29 showing the extent of cementitious top up within the cavity.

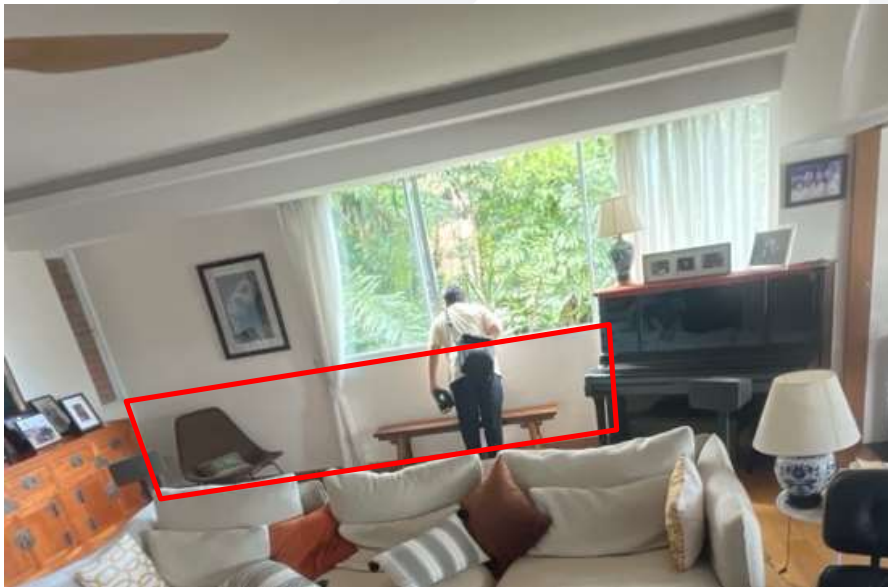
- 6.9. **The results of the second water spray test conclusively proved our hypothesis presented under sub section 5 of this report.** During heavy rains, water is able to seep through the deteriorated brick walls/ flashing joints into the cavity wall. Any water

that have seeped through into the cavity wall would be channeled towards the weep channel.
